Attabad landslide crisis in Hunza, Pakistan – lessons for the management of valley blocking landslides

#### Dave Petley Durham University, United Kingdom

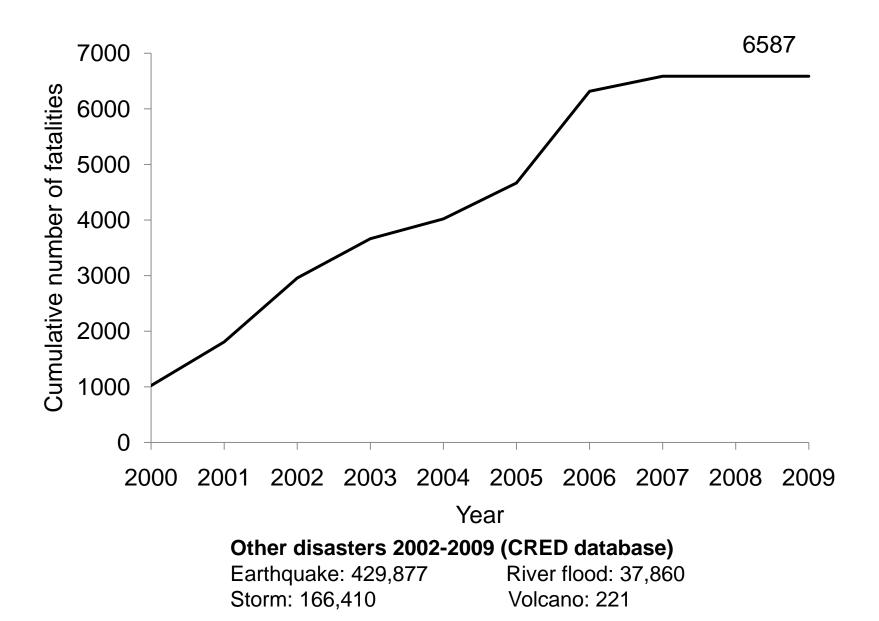
#### CRED data for landslide fatalities

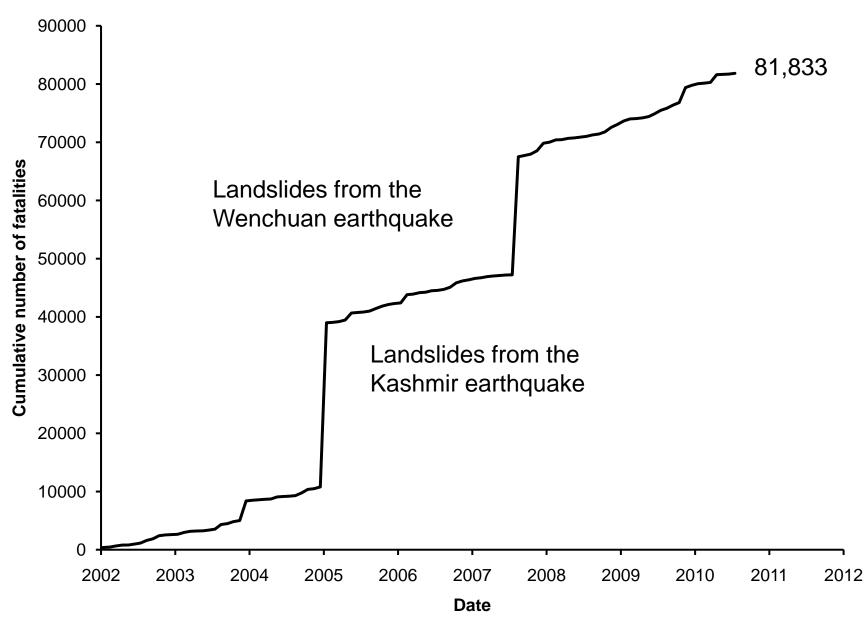
#### The (more) true human cost of landslides

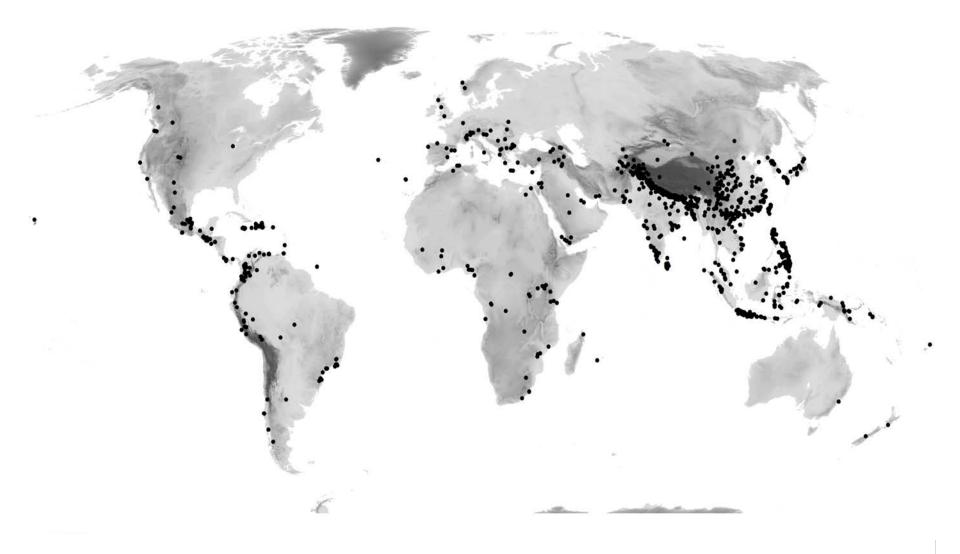
#### Global fatal rainfall-induced landslides – 2006 to 2009

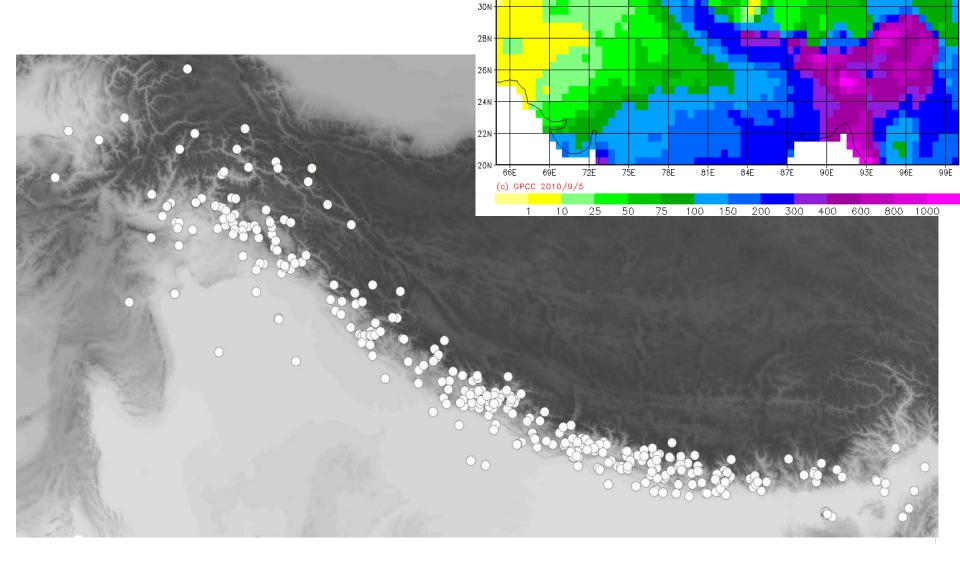
# Himalayan Arc – 2004 to 2009

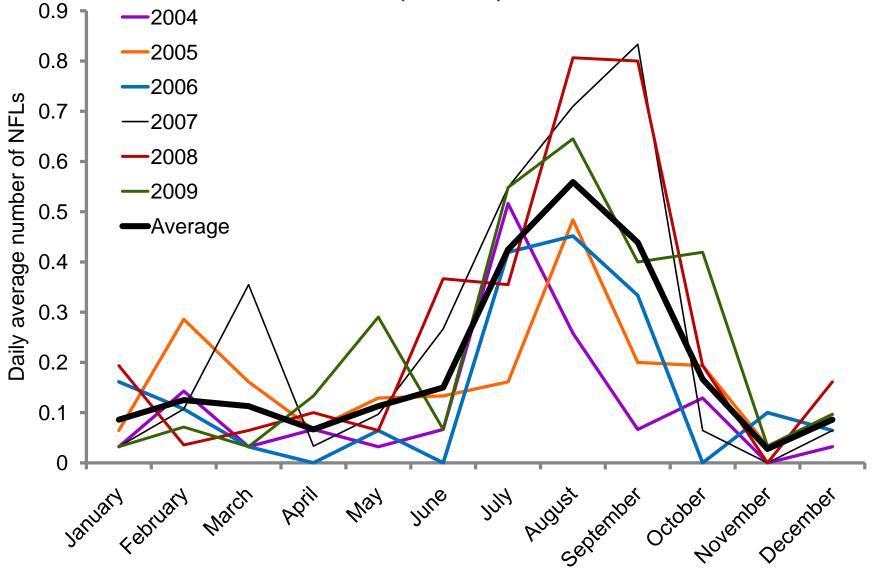
# Monthly occurrence of non-seismic fatal landslides (NFLs)

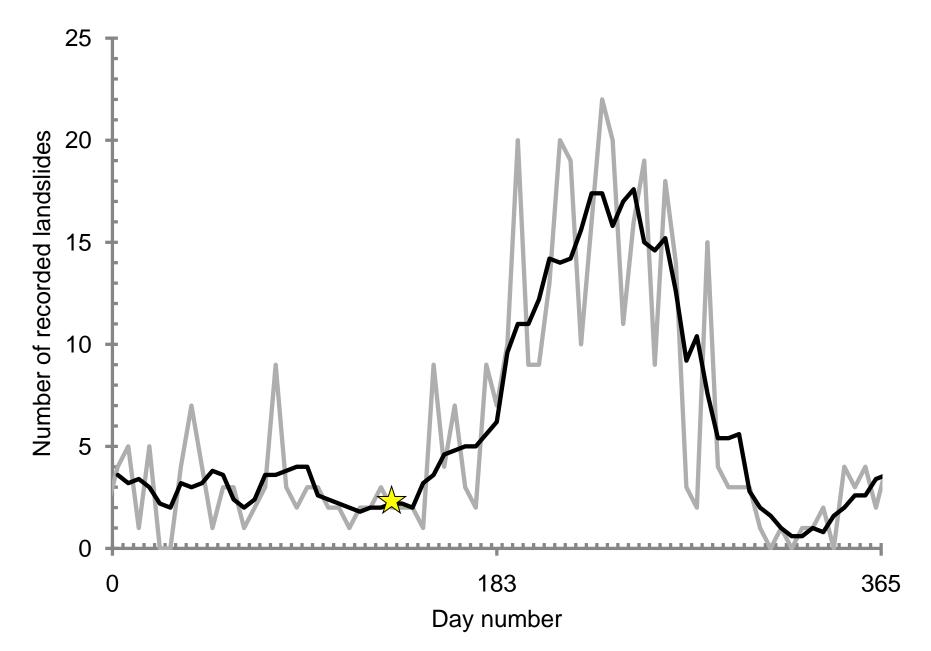
#### Annual cycle in pentads (five day bins)

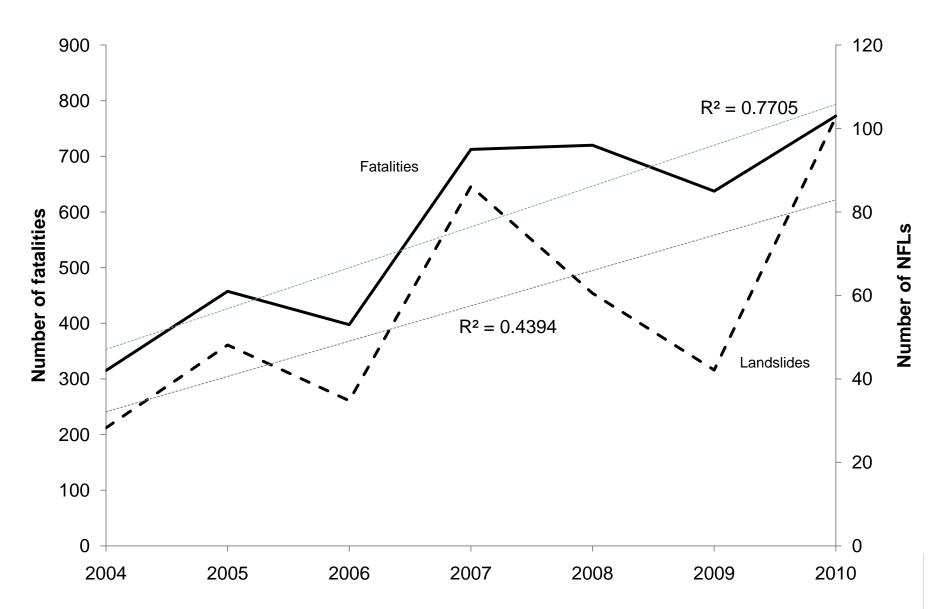
#### Trend in occurrence?

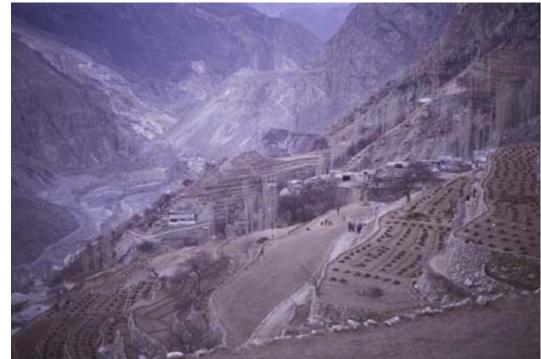
# Slope identified as unstable in 2003

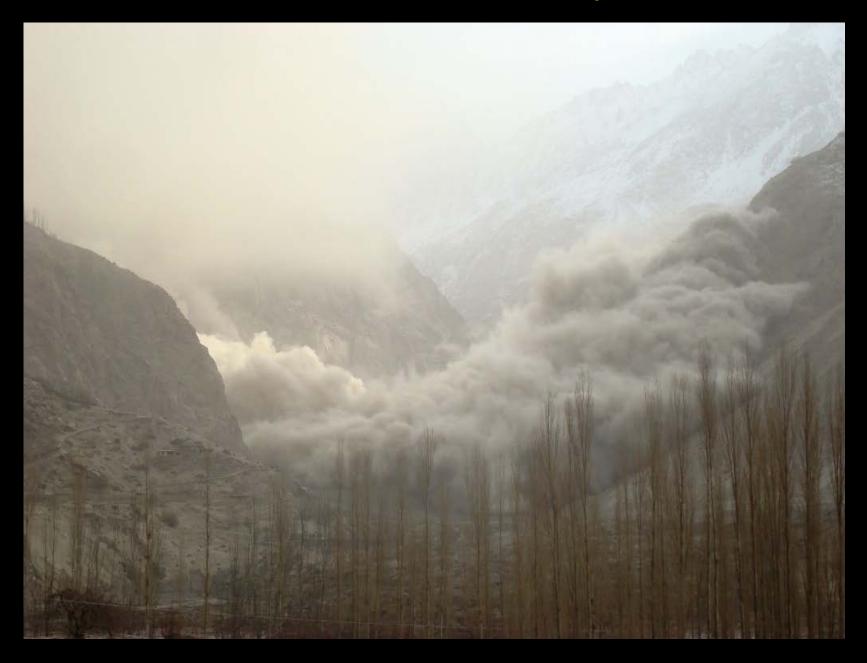
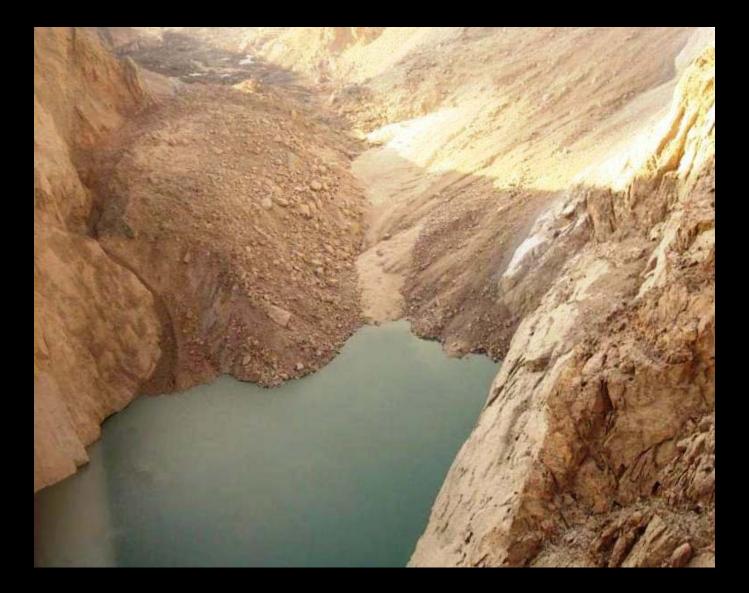
## Collapse event: 4<sup>th</sup> January 2010

1. Progressive failure over >7 years, scar height = 1175 m

2. Catastrophic failure event in Jan 2010 with no trigger

Cross valley runout = 1300 m Deposit height = 120 to 200 m

3. Emplacement of rockslide onto lake sediments triggered secondary high velocity mudflow event

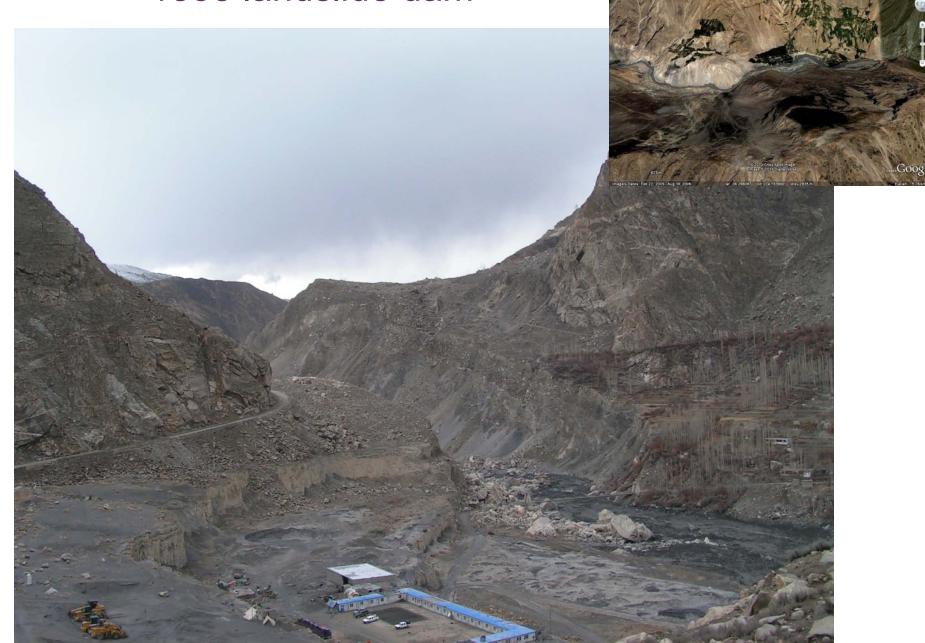
#### 1858 landslide dam

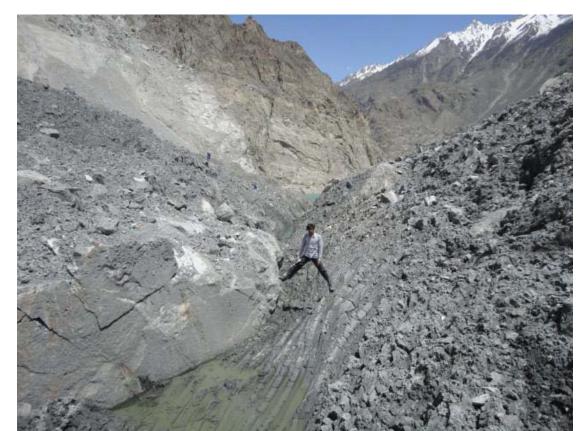
#### Management of the hazard

- Initial management response was the construction of a spillway.
  - Original intention: 30 metres deep
  - Actual depth at time of overtopping: 15 metres
  - Final spillway was very narrow and unlined

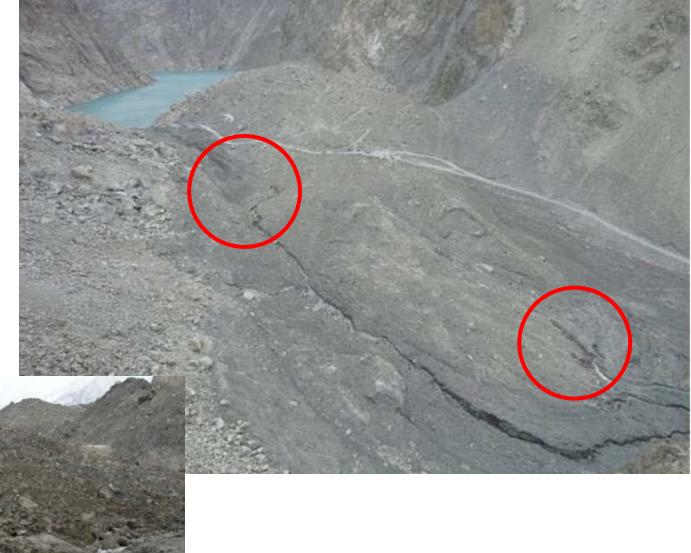
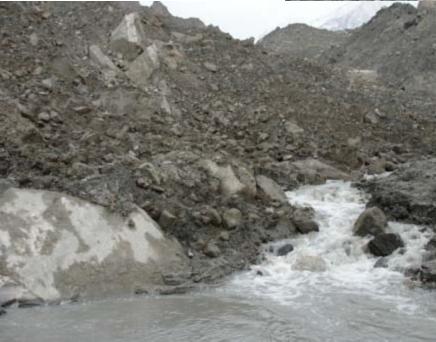
## Seepage

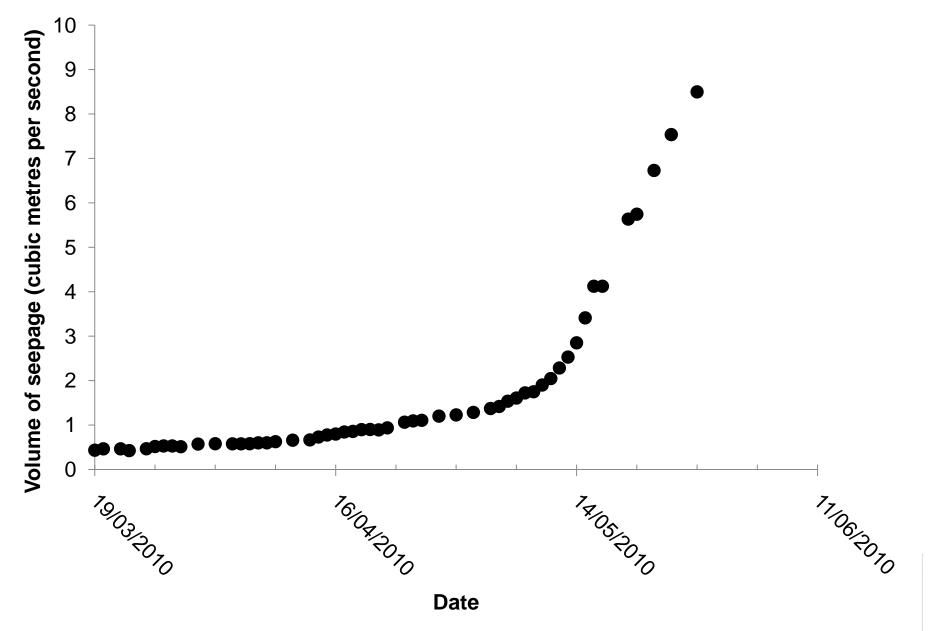
#### Seepage development

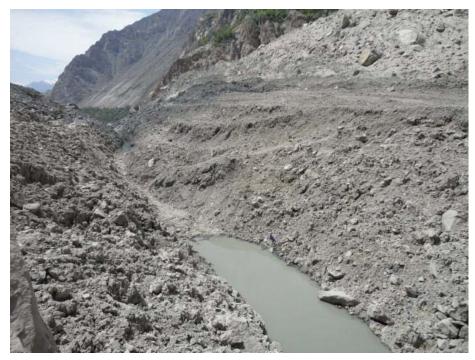
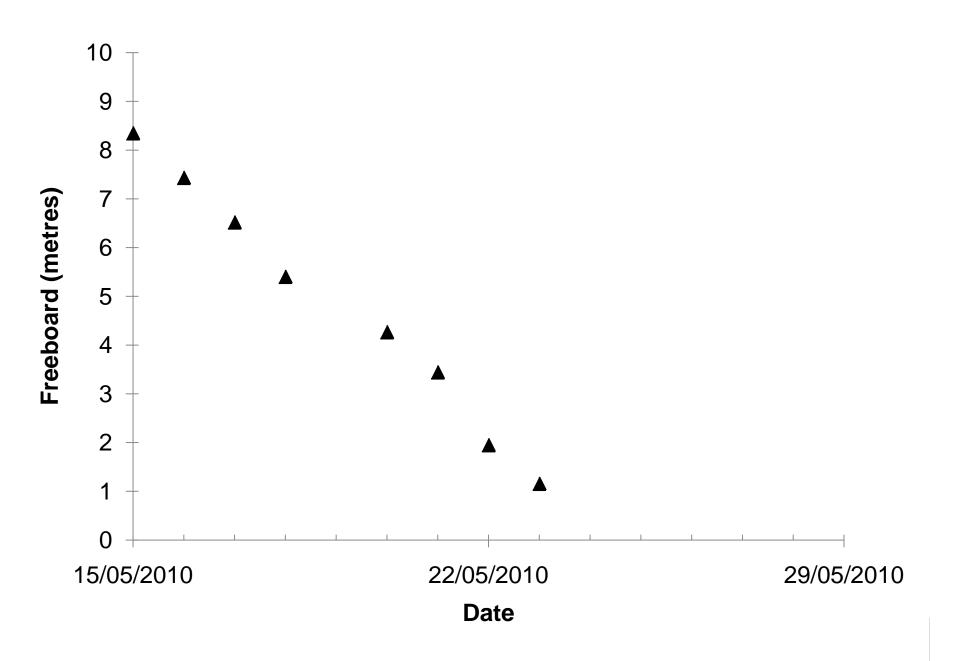
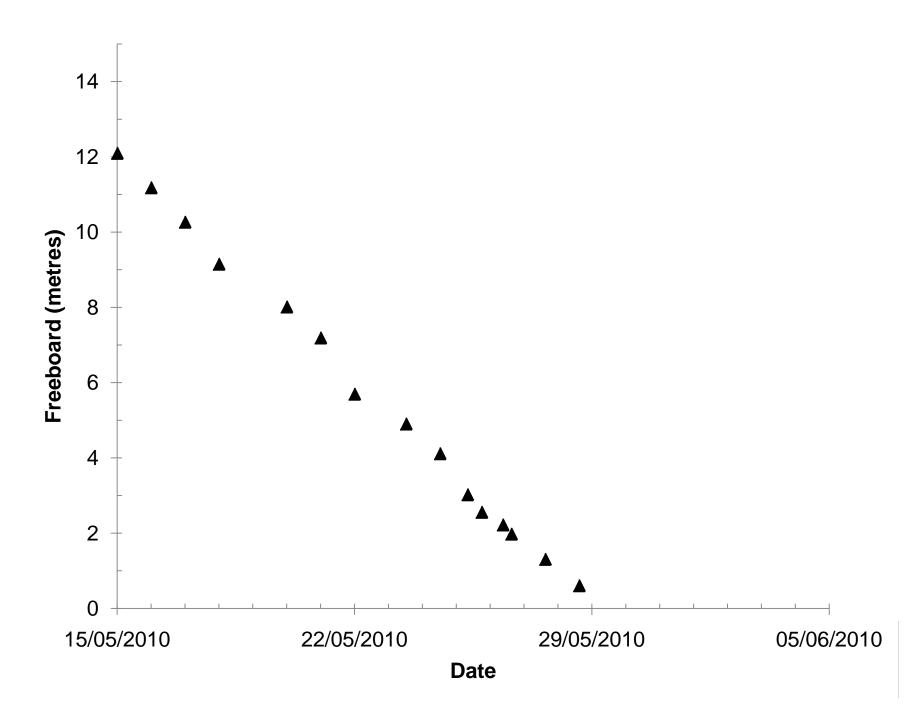
### Prediction of date of overtopping

- NDMA consistently predicted the date of overtopping incorrectly (repeatedly predicted overtopping too early)
- However, final overtopping occurred later than expected because the lacustrine silts deformed, raising the floor of the channel

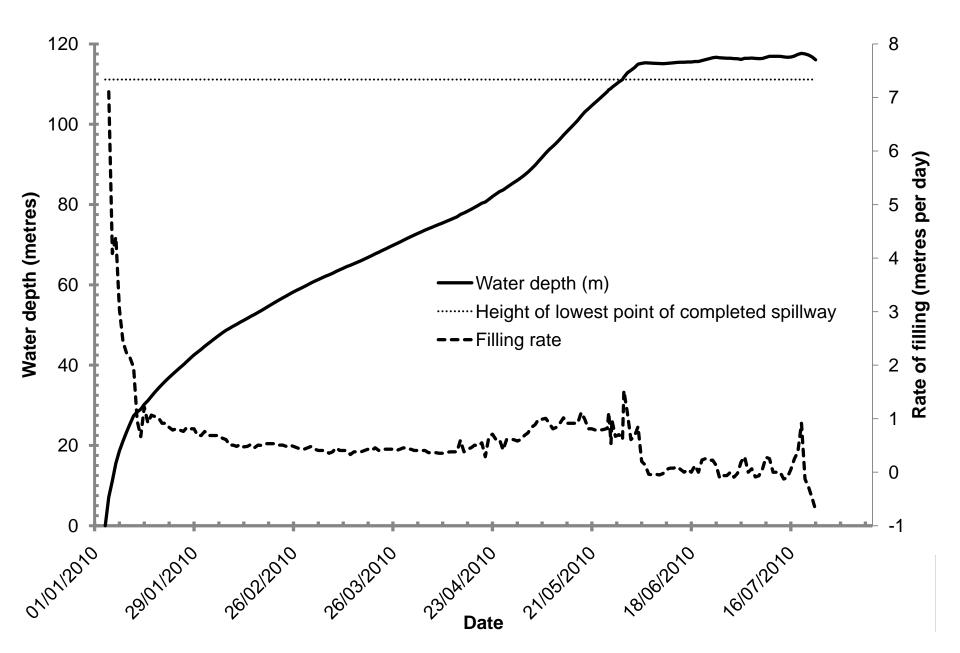
#### Water level rise

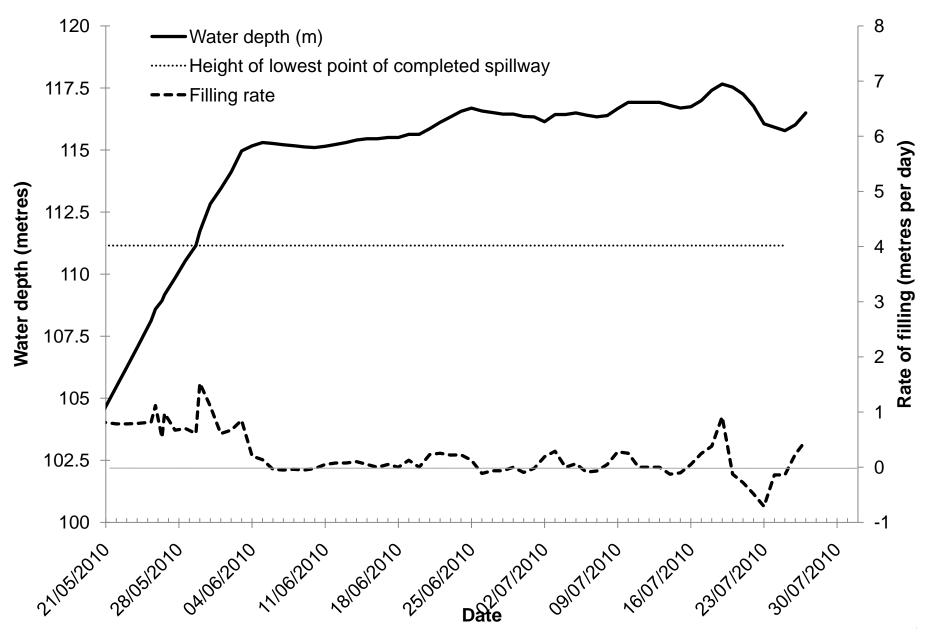
### Overtopping behaviour

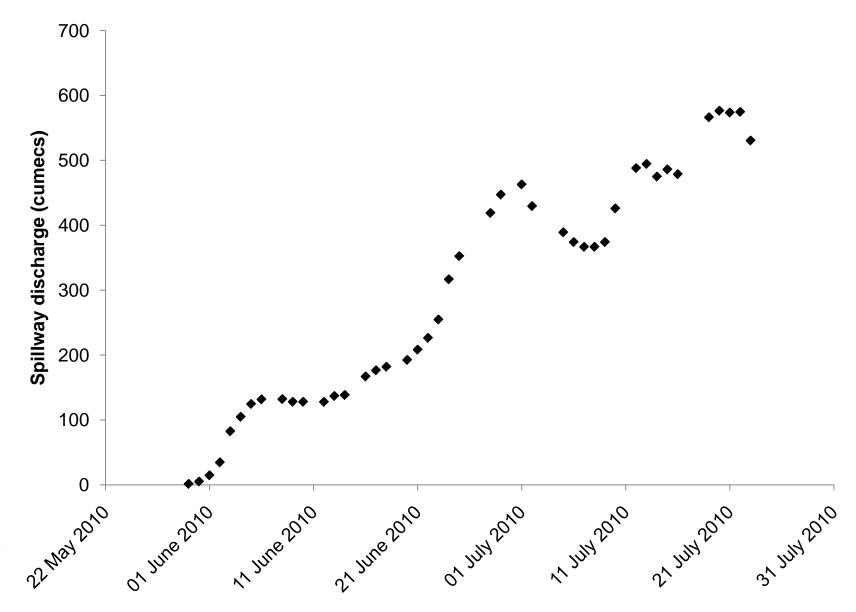
#### Evolution of spillway discharge

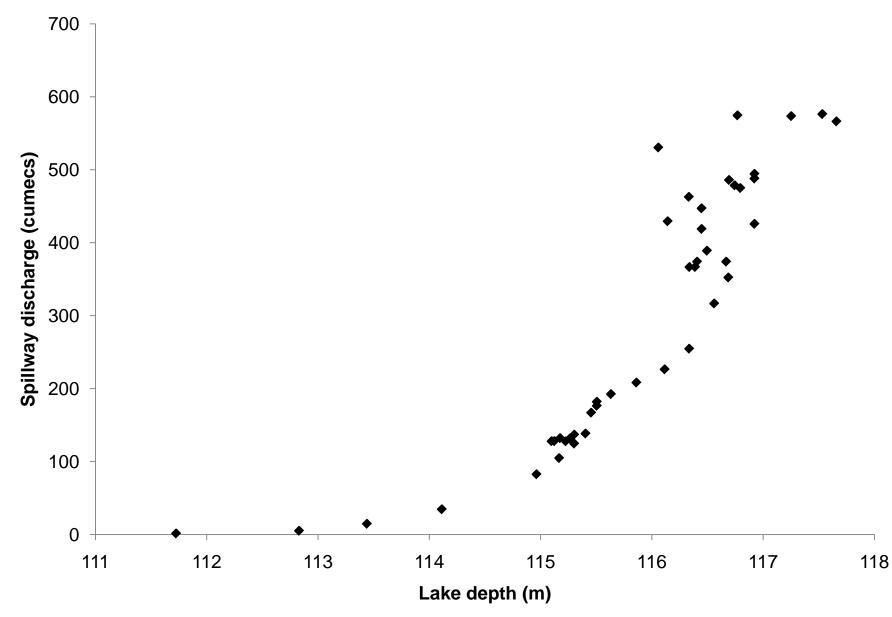
#### Spillway discharge – depth relationship

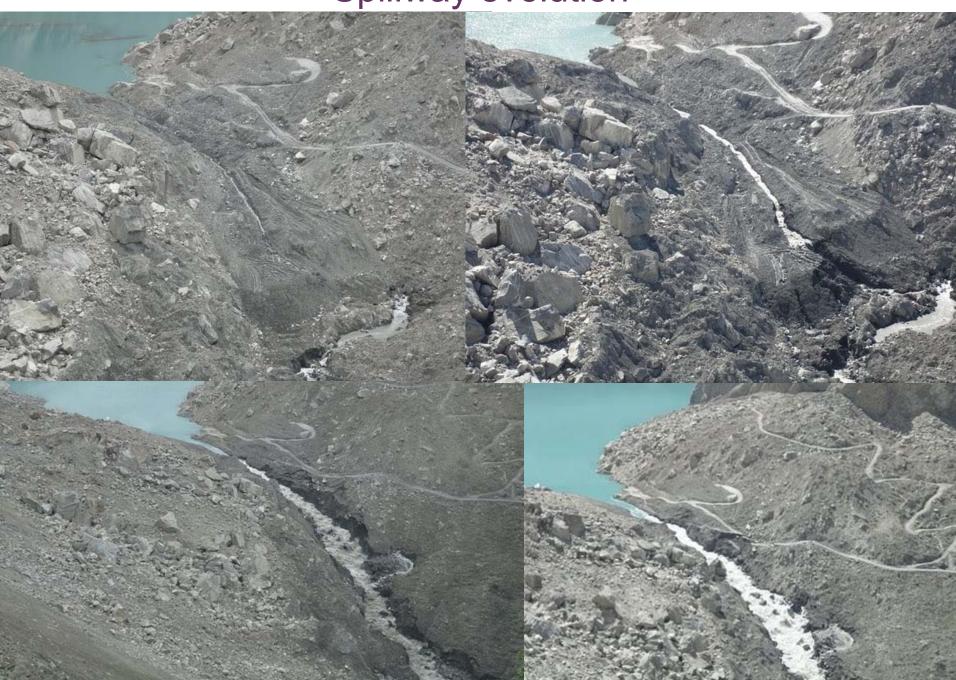
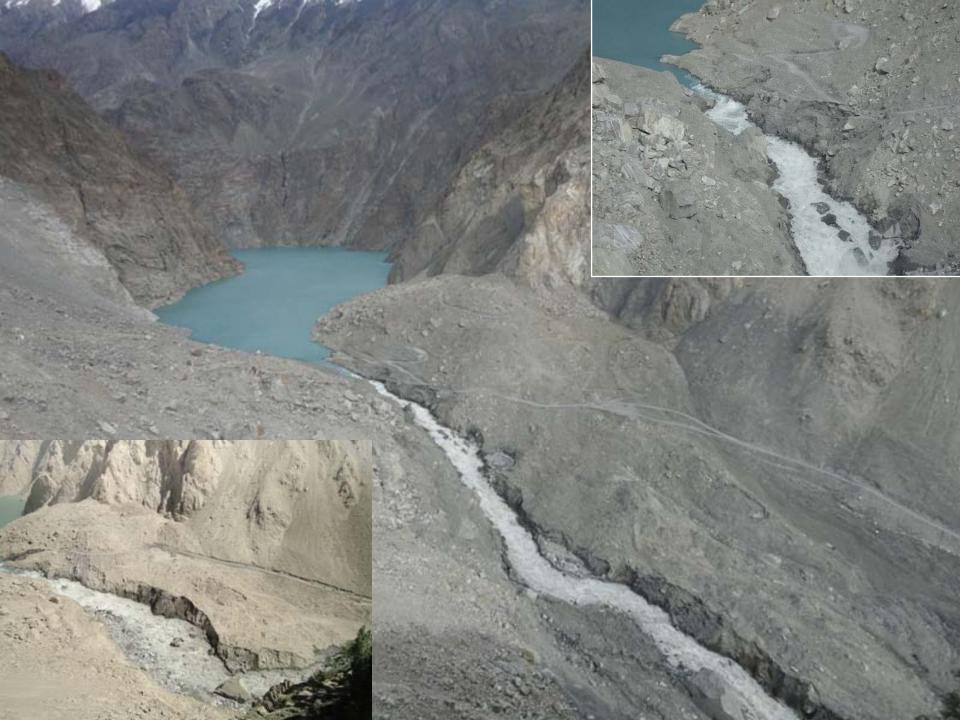
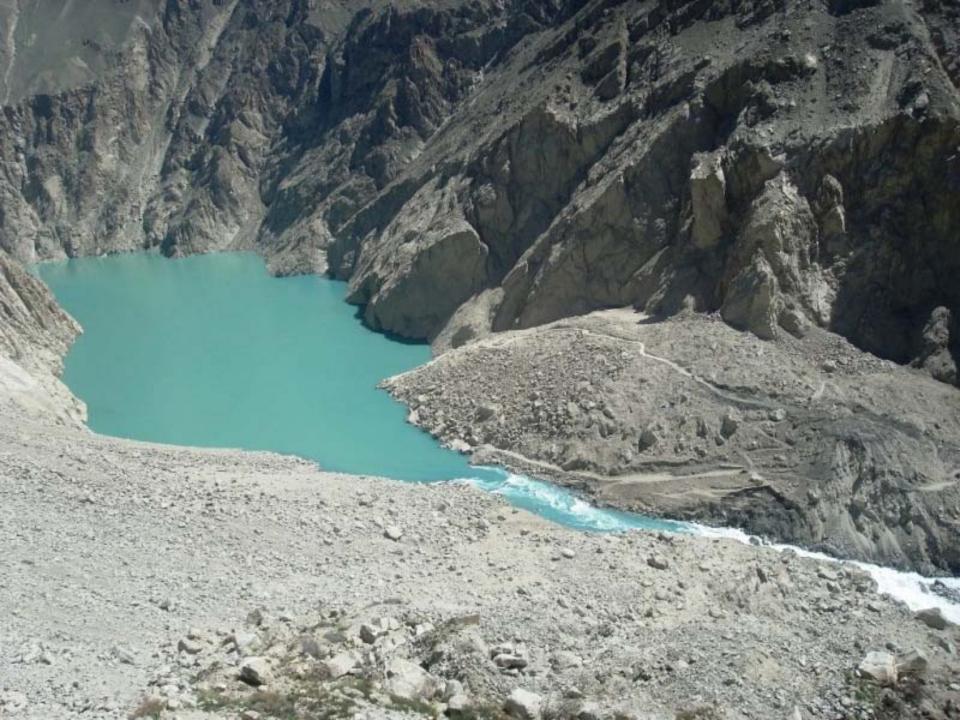
# Spillway evolution
