The Attabad landslide crisis in Hunza, Pakistan – lessons for the management of valley blocking landslides

David Petley

Institute of Hazard, Risk and Resilience, and International Landslide Centre in the Department of Geography, Durham University, Durham DH1 3LE, United Kingdom

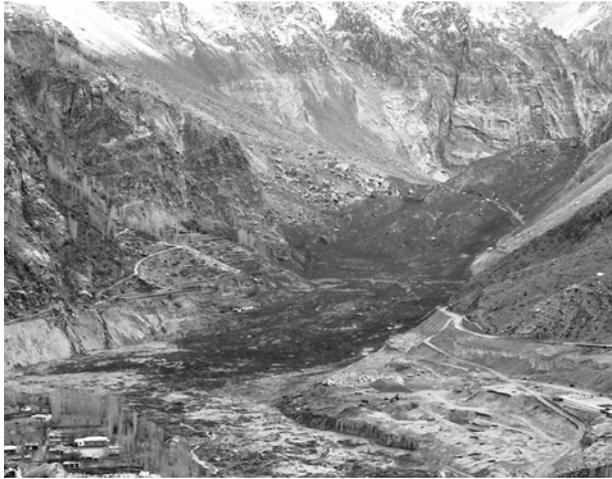
Figure 2. Photograph of the Attabad landslide looking from downstream of the dam. The source area is on the left, and the main landslide mass is on the right side, piled up on the opposite valley wall. The dark mass is the silty-clay mantling the landslide body. The saddle is clearly visible in the centre-right of the photograph.

The landslide has a maximum vertical extent of c. 1,175 m from the present crown of the landslide scar to the river bed, and the maximum horizontal displacement was about 1,300 metres (Fig. 2). The landslide body blocked the Hunza valley to a depth of about 200 m at the highest point and 120 m at the saddle. The resulting deposit was highly asymmetric, with the highest point being located on the far side of the valley from the landslide scar (Fig. 2). The across valley length of the main deposit is about 300 metres, and it is about 1.5 km in length along the axis of the valley.

The landslide process appears to have been complex, consisting of at least two different landslide mechanisms, controlled by the local geological conditions. The main failure event was a rockslide / rock avalanche consisting of a combination of bedrock and superficial deposits. The resultant deposit is chaotic, but is divided into distinct zones. For example, the upstream portion of the landslide deposit consists mostly of chaotically-organised large boulders with no matrix, whereas other parts consist of a mix of boulders and superficial deposits. This may reflect a multiphase failure process.

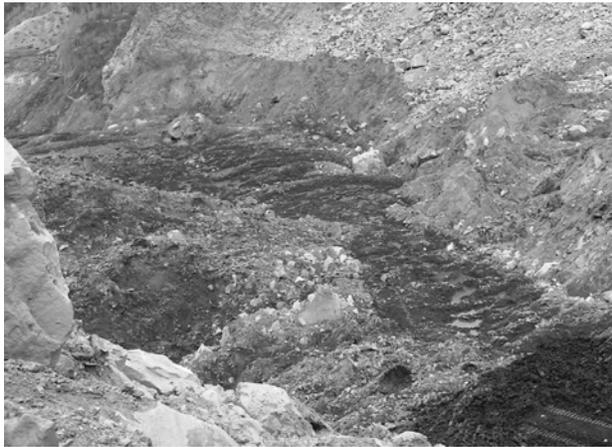
Figure 3. Photograph of the secondary mudflow that travelled downstream from the Attabad landslide, killing 19 people. The image was taken from the main landslide body. Note the flow structures and the water ponded on the surface of the mass. The fresh material in the lower right corner is spoil excavated from the spillway.

The second landslide event is associated with the superficial deposits in the valley. At Attabad the floor of the Hunza Valley comprised recent river sediments sitting over a reasonably thick, silty-clay lake bed deposit. This deposit was probably laid down in the lake that formed behind the 1858 valley-blocking landslide at Salmanabad, the site of which was located just 3 km downstream of Attabad. The first, presumably large, phase of the Attabad landslide event was rapidly emplaced onto this saturated lake-bed deposit. It appears that the emplacement induced liquefaction, presumably through

an extreme undrained loading process, causing catastrophic mobilisation of the mass (Fig. 3).

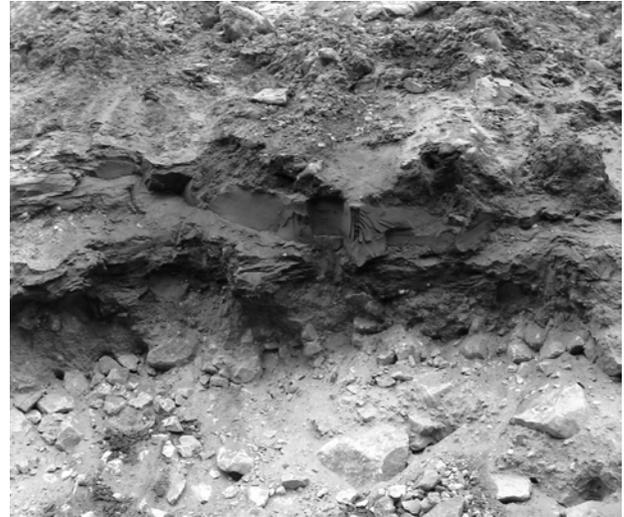
Figure 4. Photograph of the sharp contact between the silty-clay and the underlying landslide deposit. The width of the section shown is about 50 cm.

The lake bed deposit formed three separate, simultaneous flow-type landslides. The first reportedly flowed about 1.5 km in an upstream direction along the Hunza Valley, although this flow has been difficult to verify as it was inundated by the lake within a few days of the failure event. The second flowed across the valley and was then pushed up the opposite valley wall, before flowing back across the main landslide mass to be emplaced on top of it (Fig 4). The third, largest, flow
